Channel Incision and Sand Compartmentalization in an Australian Sandstone Drainage Basin Subject to High Flood Variability

W.D. ERSKINE

Abstract Wollombi Brook in the Hunter Valley, NSW, is characterised by high flood variability on a global scale (Flash Flood Magnitude Index of at least 0.86). Channel incision has occurred throughout the 2000 km² basin since initial European settlement in the early 1820s. On the main stream, discontinuous incision occurred in the upper basin in a 7 km long reach and was caused by the localised exceedance of a valley-floor slope threshold by a large flood in 1927. Since then, 900000 m³ of valley fill has been eroded by knick zone migration and subsequent channel widening but the whole sand fraction has been deposited immediately downstream in a sand slug or intermediate floodout. Between 1927 and 1982, incision moved 7 km upstream but has since stabilised due to engineering works. Non-synchronous incision of tributaries was recorded between 1838 and 1977 but the generated sand often did not reach the main stream because of deposition in intermediate floodouts/sand slugs on the tributaries. Incision of the largest tributary, Congewai Creek, was in

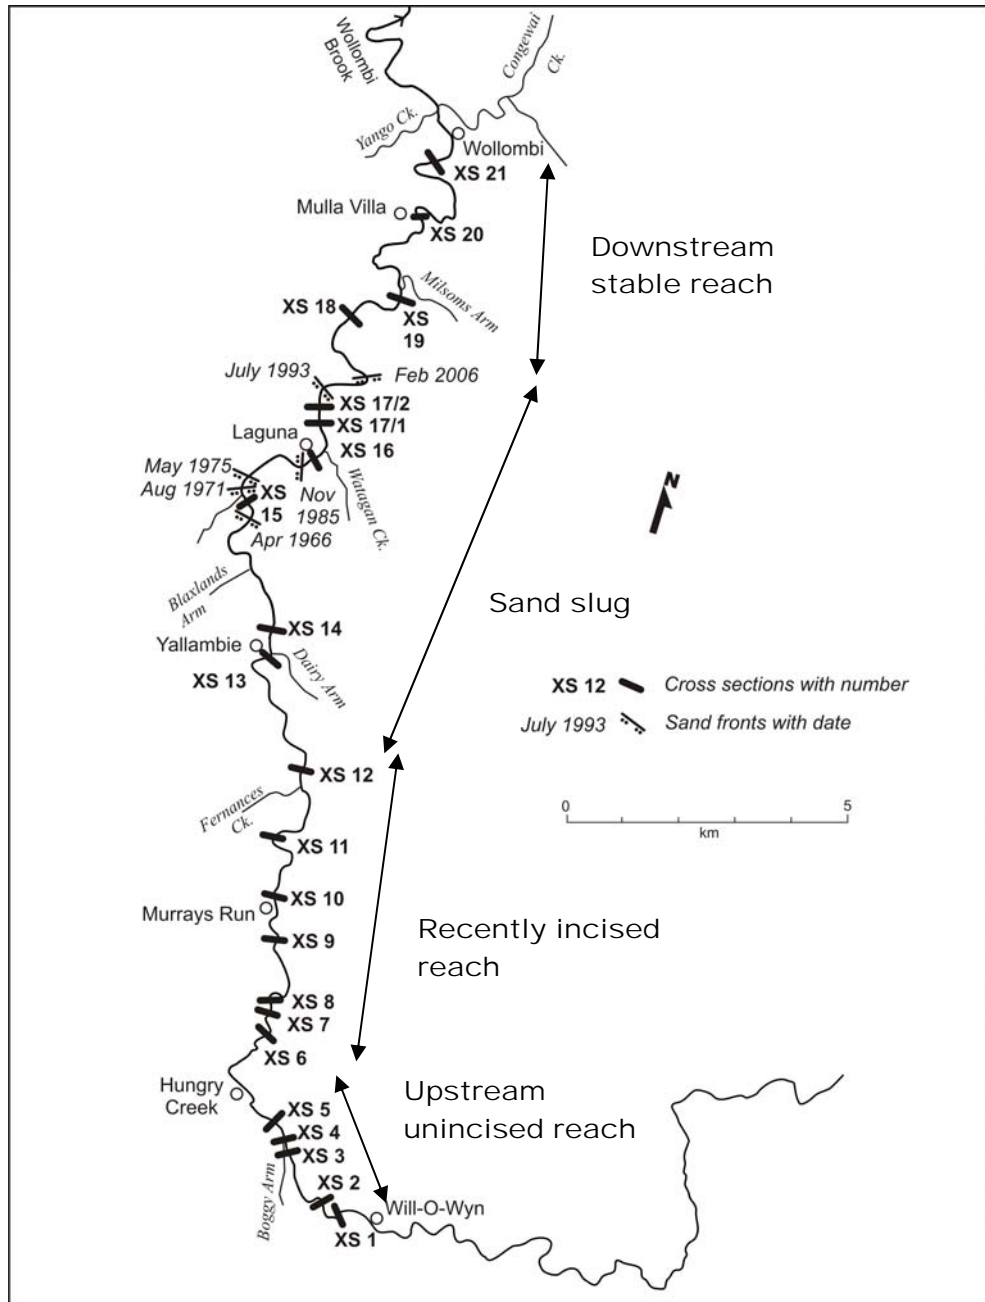
Fig. 2 Upper Wollombi Brook showing location of channel cross sections, four channel reaches and downstream movement of the sand front (downstream end of the sand slug/floodout) over time.

The depositional zone downstream of the recently incised reach has a 100% trap efficiency for sand. This *sand slug or intermediate floodout* now extends from cross section 12 to downstream of cross section 17 (Fig. 2). Intermediate floodouts are sites where channelized flow ceases and floodwaters spill across the valley floor before rejoining as a channel further downstream (Tooth, 1999). While Wollombi Brook now has a continuous channel through the sand slug, this has not always been the case since 1927. Fernances Creek, Dairy Arm, Blaxlands Arm and Watagan Creek all flow into Wollombi Brook in the sand slug. However, only Dairy Arm has contributed significant amounts of sand to Wollombi Brook. While the sand slug first formed in 1927, it is only since April 1966 that the downstream movement of the front of the sand slug (sand front in Fig. 2) has been mapped by Page (1972) and the author. Massive overbank deposition at cross sections 14, 15 and 16 has greatly exceeded bed aggradation and has rapidly formed high natural levees, which locally increase bankfull channel capacity and stream power (Fig. 3). These overbank deposits correspond to the Fernances Formation of Erskine & Melville (2008) and are certainly post-European settlement in age because they bury introduced fruit trees at cross section 14; they completely bury fence posts at cross section 16; and they buried an old convict stone crossing of a flood chute at cross section 13. The sand slug has buried extensive chain of ponds that were formerly connected by a small sinuous channel (Dangar, 1825; Matthews, 1830). A 2 km long pond was present at cross section 15 (Dangar, 1825). The then Surveyor General, Major T.L. Mitchell (1839: 11-12) first described chain of ponds on Wollombi Brook in this reach during his expedition into the interior of Australia in November 1831. Sinuosity currently varies between 1.15 and 1.20, and is comparable to the incised reach. A neck cutoff at cross section 11 was abandoned in 1949 and used to form part of an extensive pond system that was fished by local residents before the cutoff occurred (Nev Thompson, land owner, pers. comm., 1985).

The *downstream stable reach* extends from the sand front to within 0.5 km of the Congewai Creek junction (Fig. 2). The channel has a small capacity of low to extremely low stream power (Fig. 3). Sinuosity increases from 1.28 between cross sections 17 and 19 to 1.58 at cross section 21. However, some short sections have sinuosities as high as 1.95. Bedrock is exposed in the bed between cross sections 17 and 19 and the floodplain becomes progressively confined by a resistant sandstone bed of the Triassic Narrabeen Group near Wollombi. Although Page (1972) maintained

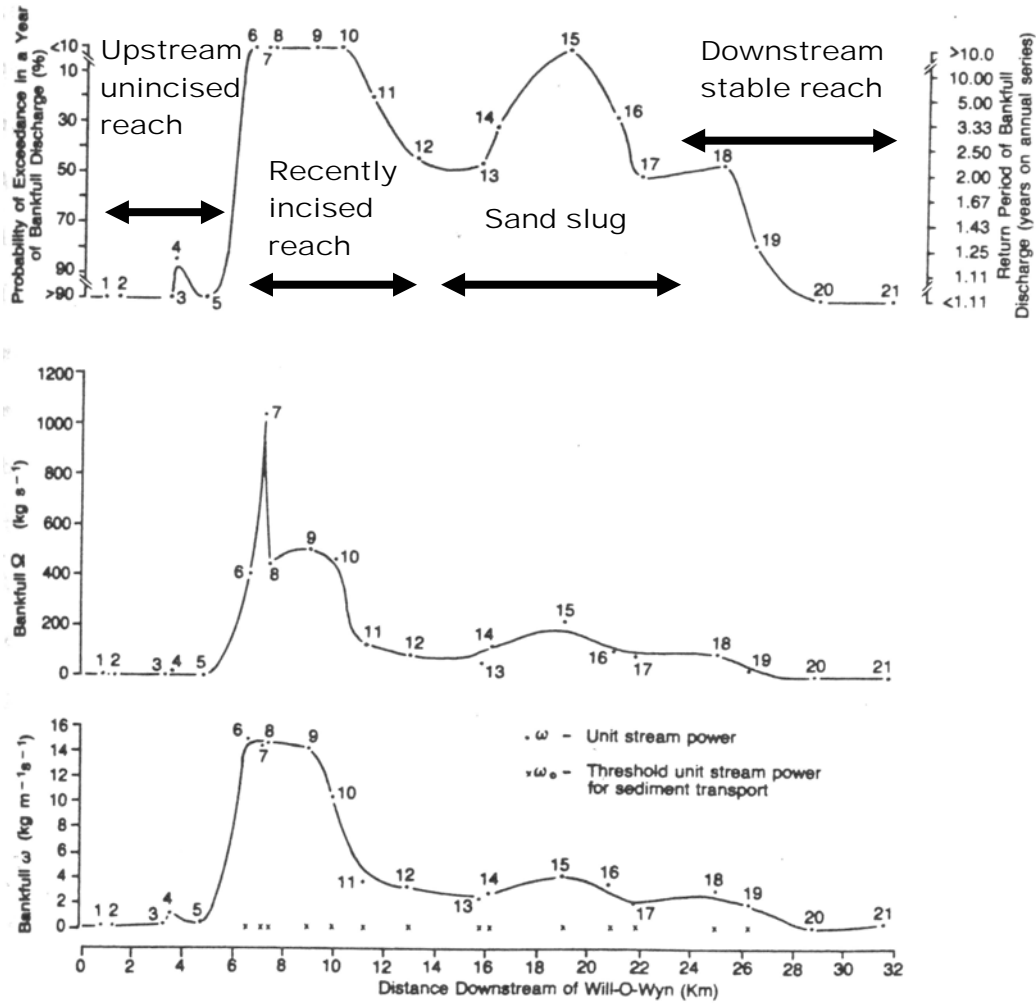
Fig. 3 Downstream trends in the probability of occurrence of bankfull discharge, and bankfull total, unit and threshold stream power for sediment transport on upper Wollombi Brook. Location of channel cross sections shown in Fig. 2.

Fig. 3 shows downstream variations in the probability of occurrence of bankfull discharge, bankfull total stream power (Ω), bankfull unit stream power (ω) and threshold stream power for

sediment transport (ω_0) at each of the 21 channel cross sections on upper Wollombi Brook (Fig. 2). The above four reaches are clearly illustrated. The *upstream unincised reach* experiences frequent overbank flow, has low bankfull total and unit stream power (Fig. 3) and has a sinuosity of 1.53. The channel is currently stable because the peak discharge of catastrophic floods is routed across a broad, vegetated, polygenetic floodplain (Erskine & Melville, 2008). The *recently incised reach* is characterised by the greatest channel capacity and stream power (Fig. 3). Bed slope also increases significantly and sinuosity decreases to 1.16 due to 10 cutoffs since 1949. The knick zone (after Schumm *et al.*, 1984) at the head of incision moved 7 km upstream after incision was initiated about 600 m upstream of the Fernances Creek junction on a locally steeper section of floodplain by a large flood in 1927 (Hal Nichols, property owner, pers. comm., 1981). Initially a 2 m high 'waterfall' cut into 'topsoil' overlying 'sand' was present during the large floods of 1927 and 1929. Between 1929 and June 1949 the headcut was effectively stationary. However, the headcut rotated into a 1 km long knick zone (Schumm *et al.*, 1984) during the catastrophic flood of 17-18 June 1949 and migrated 3.5 km upstream in two days. Plate 1 shows the valley floor near cross section 10 before, during and immediately after the June 1949 flood. Between July 1949 and 1982, the knick zone migrated a further 3.5 km upstream. Fig. 4 shows the upstream extension of incision by 1.4 km and subsequent channel widening between August 1969 and July 1979. A number of chain of ponds mapped in 1825 (Dangar, 1825) were drained and eroded by such incision and widening. Channel erosion was caused by the large bankfull stream power (Fig. 3). However, the catastrophic June 1949 flood inundated the whole floodplain (Plate 1B), as did the subsequent large flood in March 1978. Although government-sponsored river training works were commenced on upper Wollombi Brook in 1967, no attempt was made to stabilise the knick zone until 1982. It was maintained that the 'clay bars' near cross sections 6 and 7 (Fig. 4) would stop upstream migration of the knick zone. These 'clay bars' are never finer than sandy clay loams and are part of the Boggy Formation of Erskine & Melville (2008), which becomes indurated on exposure by erosion. Large floods in March 1977 and March 1978 totally breached the bars and, as a result, upstream incision continued (Fig. 4). Four consecutive rock weirs were built in 1982 and they have proved successful in stopping the incision. At least 900000 m³ of valley fill was eroded by historical incision between 1927 and 1982.

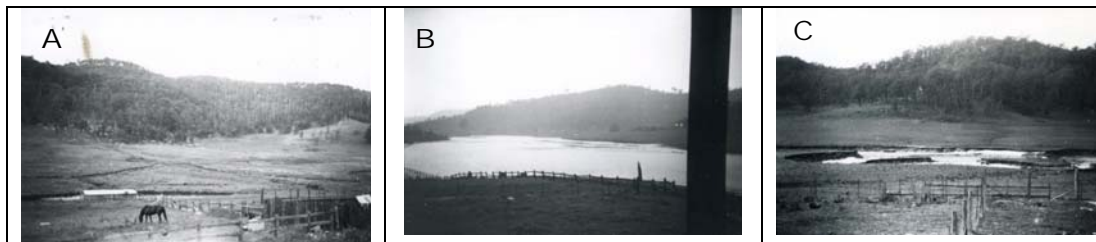
Plate 1 (A) Wollombi Brook near cross section 10 before the 1949 flood, showing a vegetated, small capacity channel. (B) Near the same location as (A) on morning of 18 June 1949, after the flood had receded below the peak reached the previous night. (C) Near the same location as (A) immediately after the June 1949 flood, showing recently incised channel. Location of cross section shown in Fig. 2. Photographs kindly supplied by the late H.C. Nichols, property owner at cross section 10.

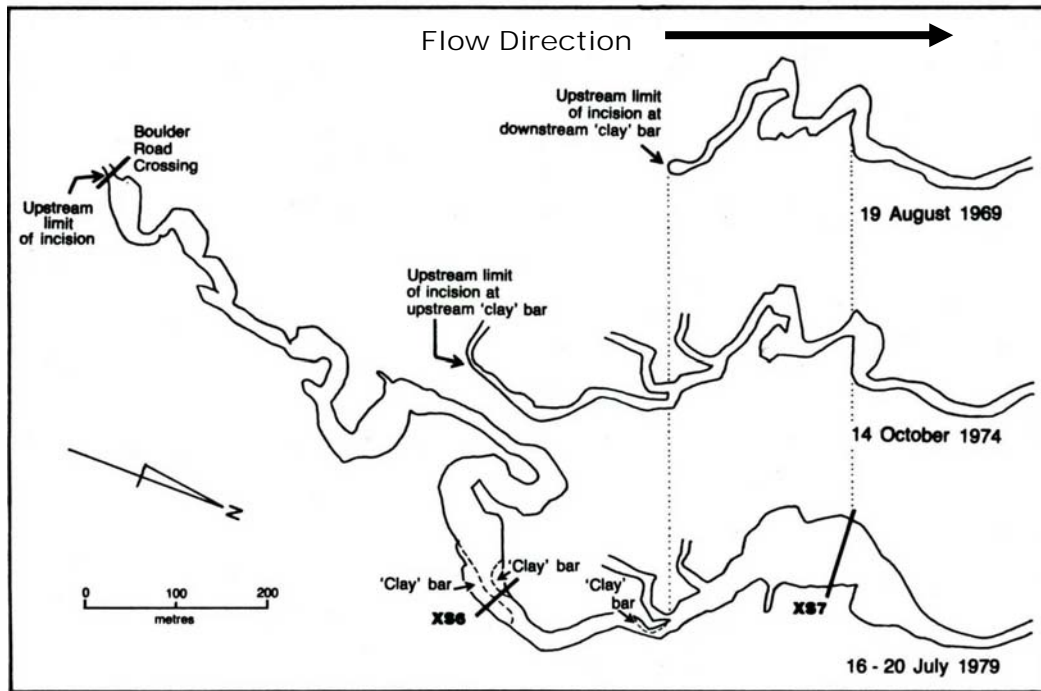
Fig. 4 Upstream extension of channel incision and widening of Wollombi Brook at Hungry Creek between 1969 and 1979, as determined by field surveys. Location of cross sections shown in Fig. 2.
